AFTER ACTION REPORT

CH-47 RECOVERY USING D-PAAC

July 1985

Hover Systems Federal Corp.
Eddystone, PA
DAAK70-85-C-0014

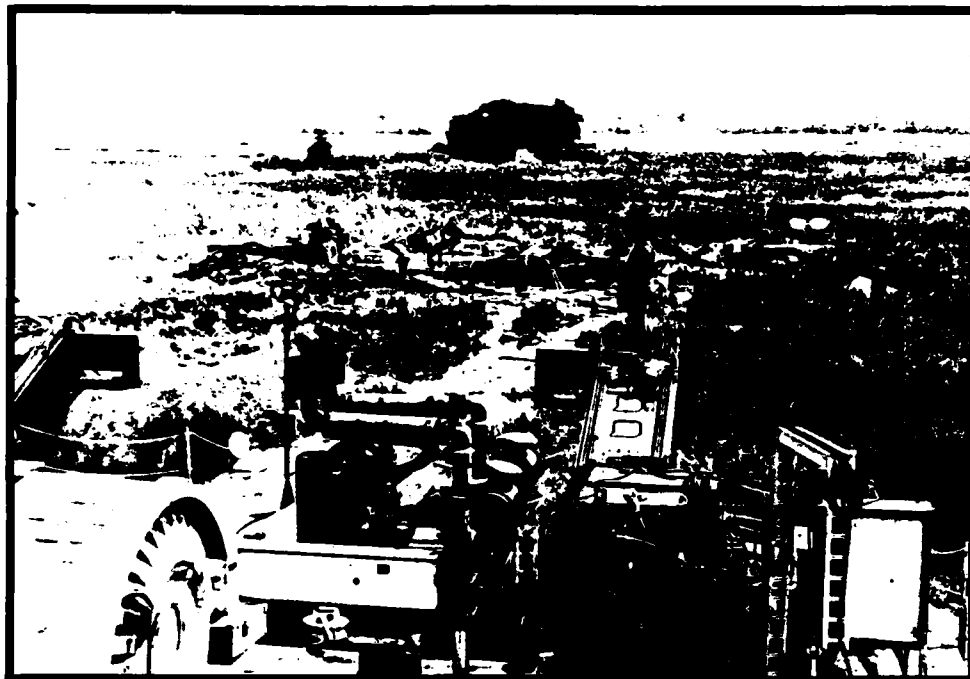
CRASH SITE AND APPROACH

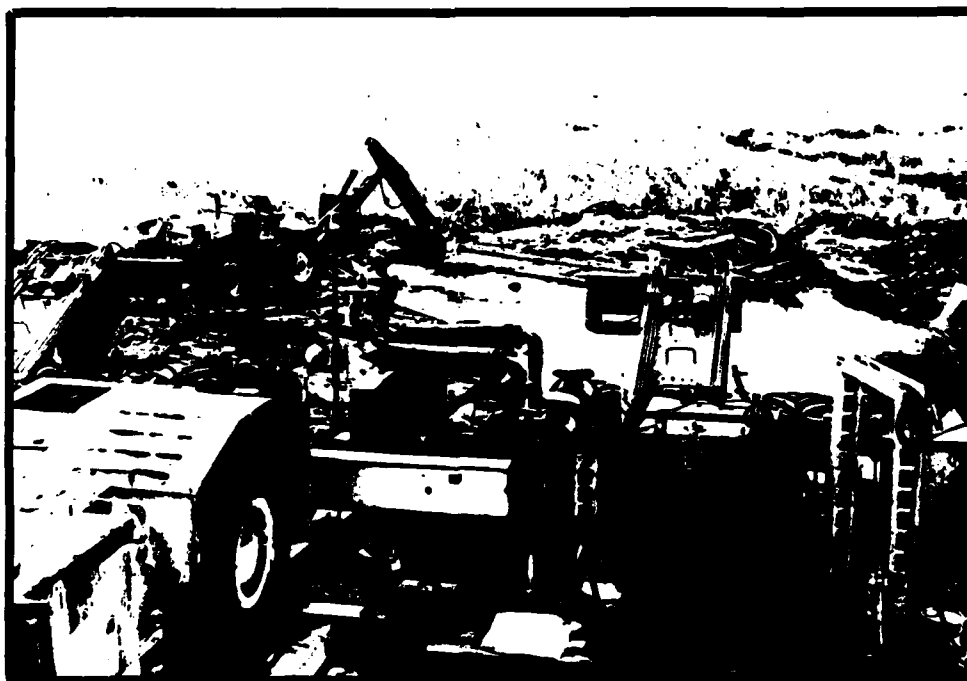
CRASH SITE AFTER RECOVERY

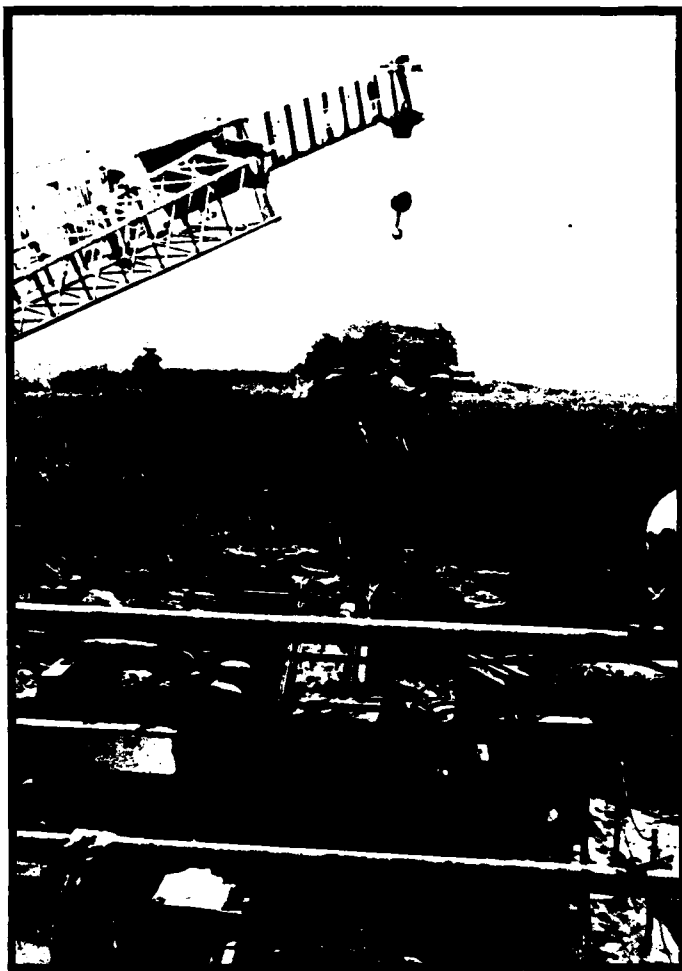
WRECKAGE RECOVERY
